Job No: 7747/26
Our Ref: 7747/26-AA-R1
25 July 2016

re: **Redbank Residential Development
Grose Vale Road, North Richmond
Site Classification Report - Mountain View & The Gallery**

Test Pit Locations

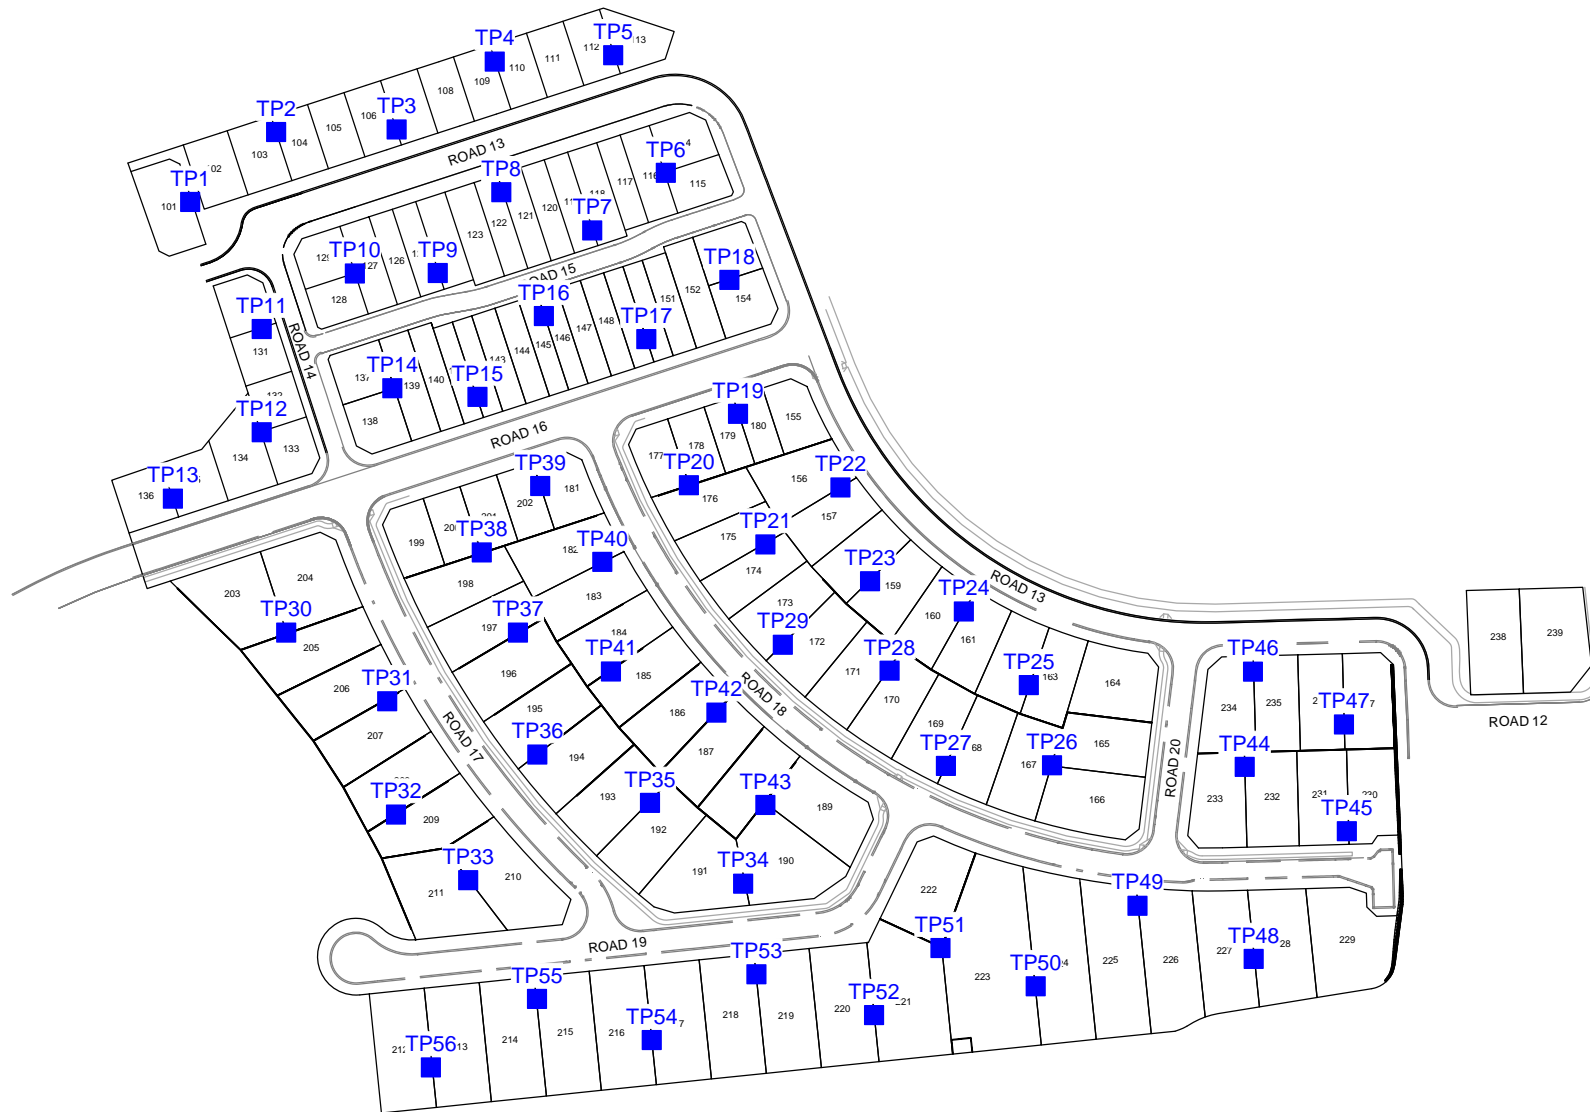
Drawing No: 7747/26-AA1
Job No: 7747/26
Drawn By: MH
Date: 27 June 2016
Checked By: AI

The site investigation was carried out between 22 and 24 June 2016, under the supervision of a Geotechnical Engineer from the company and consisted of excavating 56 test pits (TP1 to TP56), using an excavator. The test pits were terminated at a depth of 1.5m and their approximate locations are indicated on the attached Drawing No 7747/26-AA1. The brief descriptions of materials encountered in the test pits are provided in the attached Table A.
