re: **Redbank Development – Southern Heights
Grose Vale Road, North Richmond
Site Classification Report**

7747/57-AB-R1
 Redbank Development – Southern Heights
 Grose Vale Road, North Richmond

Test Pit Locations

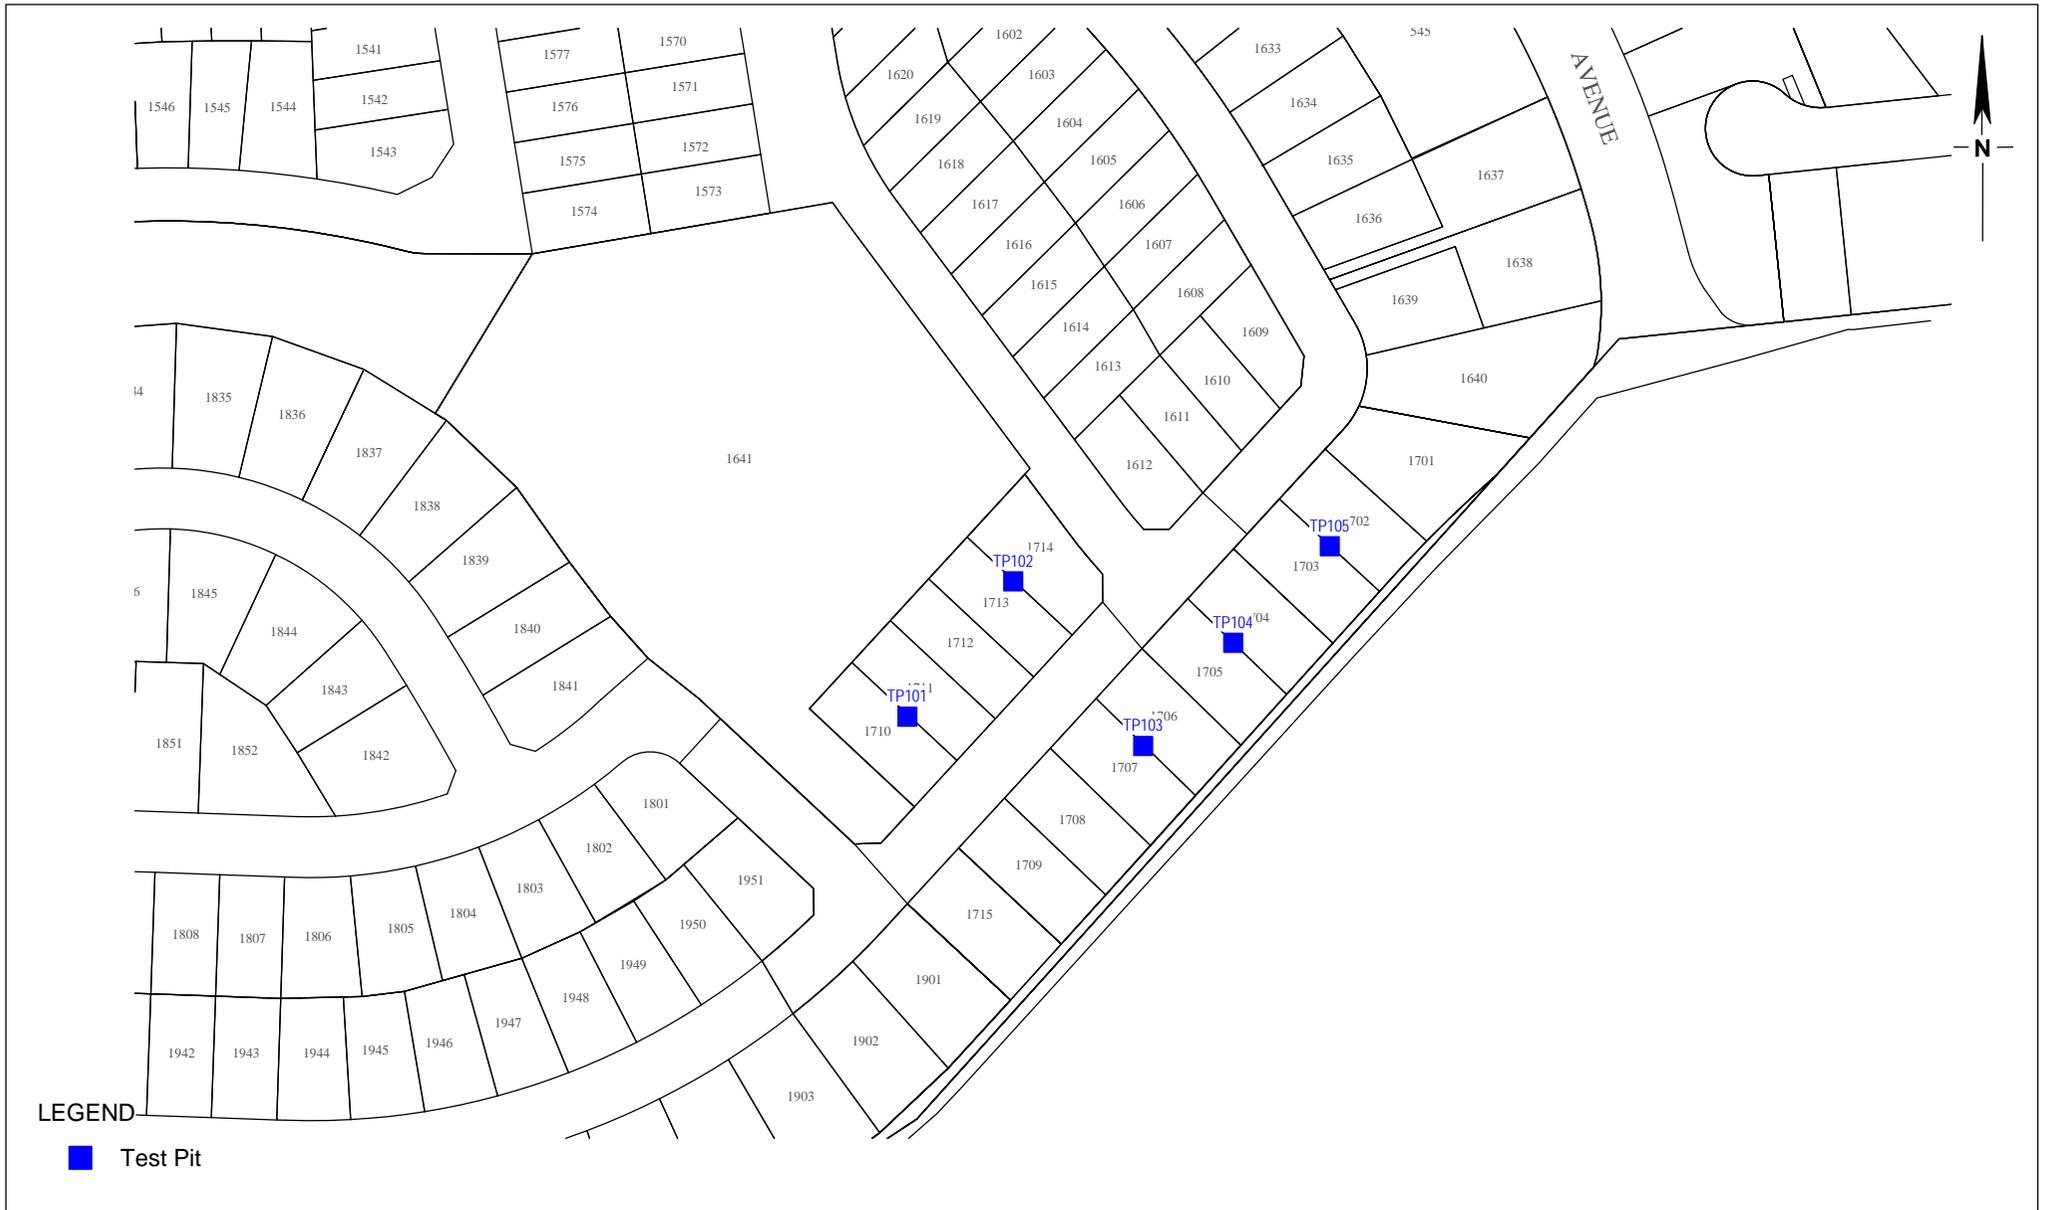
Drawing No: 7747/57-AB1
 Job No: 7747/57
 Drawn By: MH
 Date: 13 January 2022
 Checked By: ZA

The investigation work was conducted on and 15 December 2021 and 28 January 2022, under the supervision of Geotechnical Engineers from the company and consisted of excavation of twenty-two (TP101 to TP122), using an excavator. The approximate test pit locations are indicated on Drawings 7747/57-AB1 and 7747/57-AC1. The test pits were terminated at a depth of 1.5m from existing ground level. Description of subsurface materials encountered in the test pits is provided in the attached Table A.

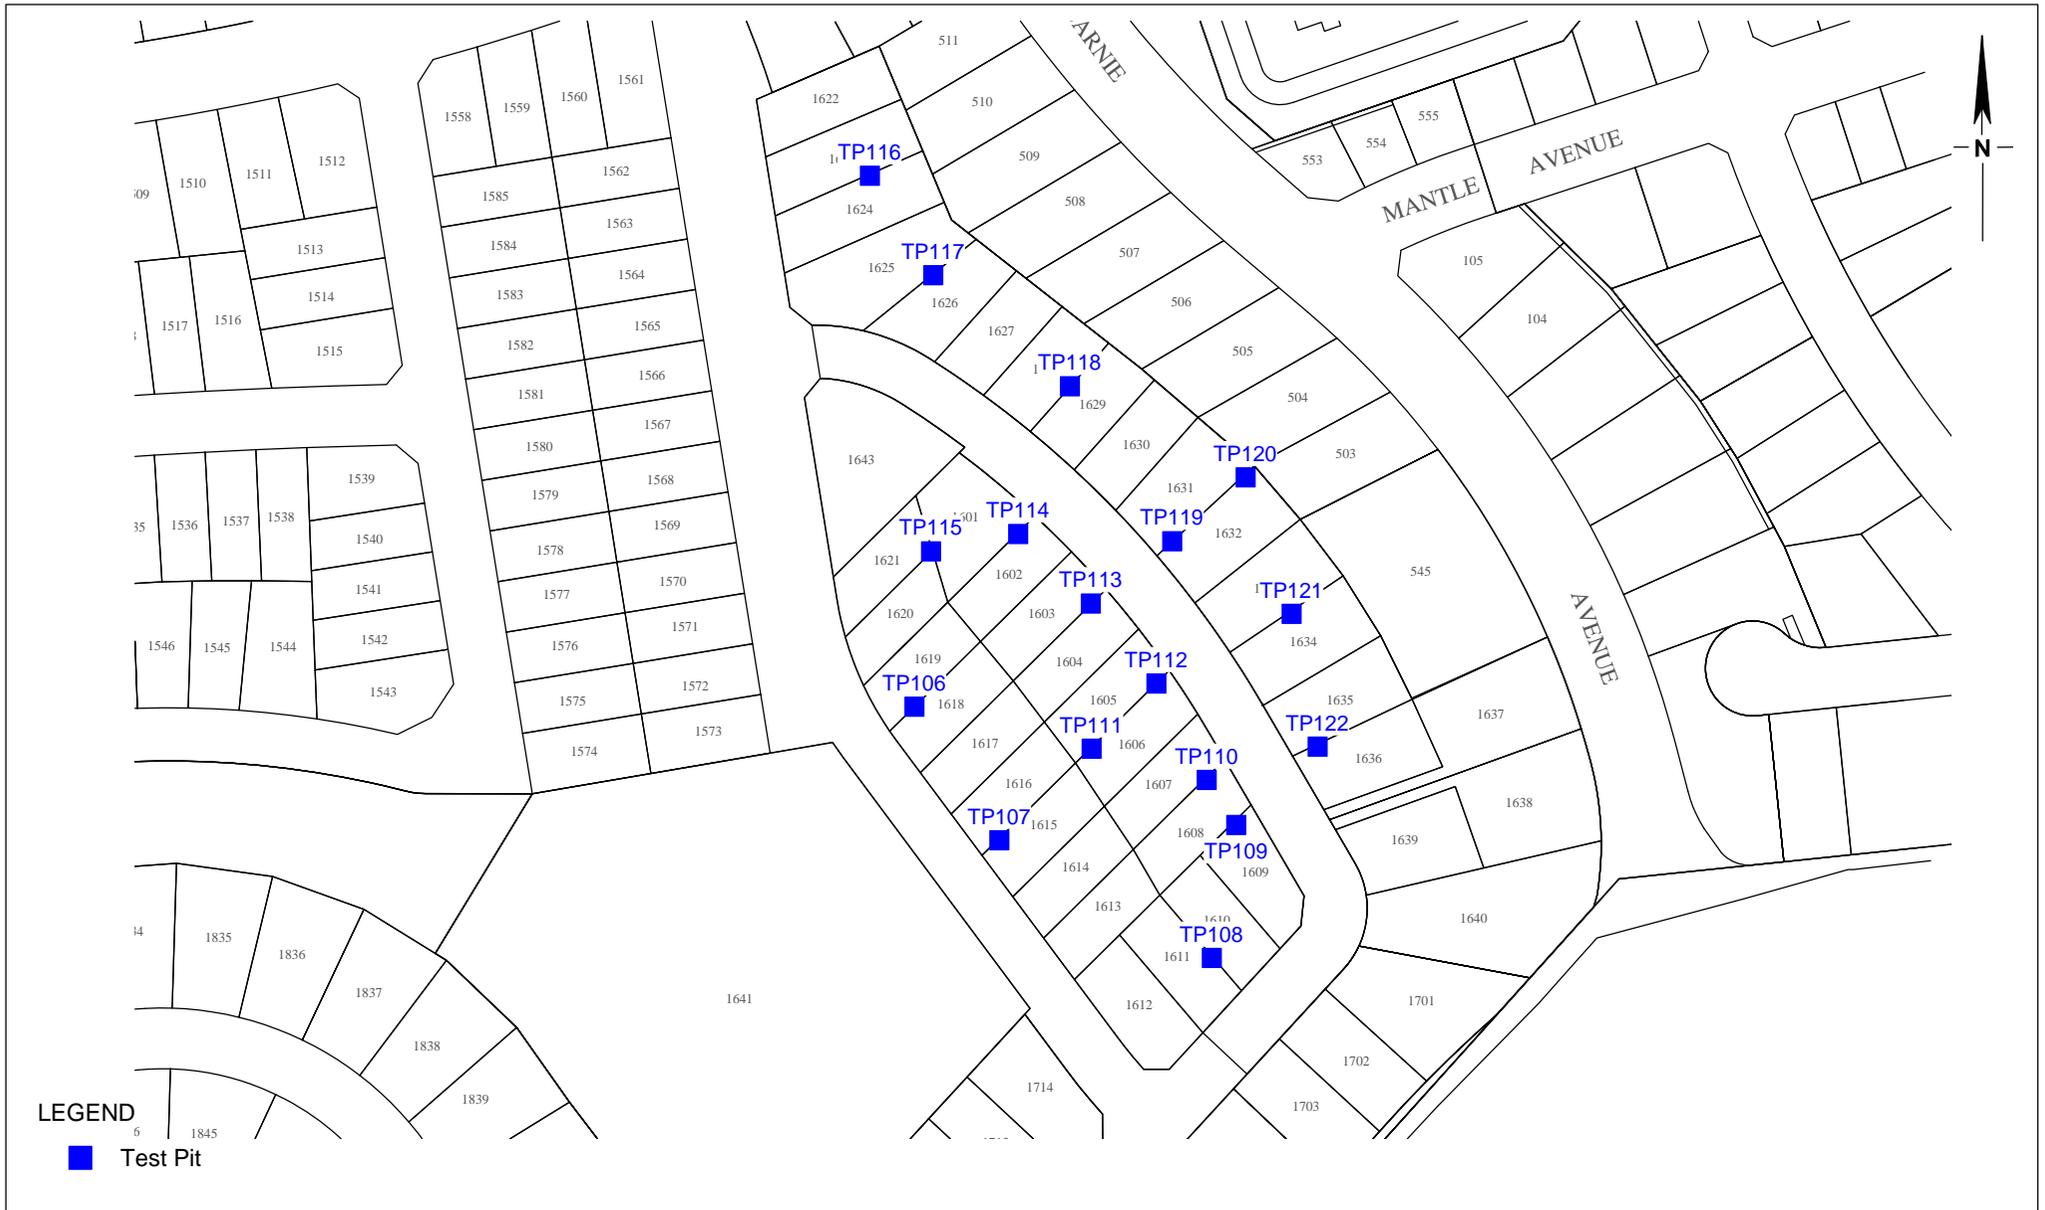
Drawing No: 7747/57-AC1
Job No: 7747/57
Drawn By: MH
Date: 2 February 2022
Checked By: ZA

Test Pit Locations
